**NONDESTRUCTIVE ANALYSIS OF  
SALES GAS LINE PIPE EVIDENCE  
FROM THE WEST COTE BLANCHE  
BAY PIPELINE RUPTURE INCIDENT**

**Prepared For The  
NATIONAL TRANSPORTATION  
SAFETY BOARD  
Washington, DC**

**FEBRUARY 27, 2007**

**PN 131454**

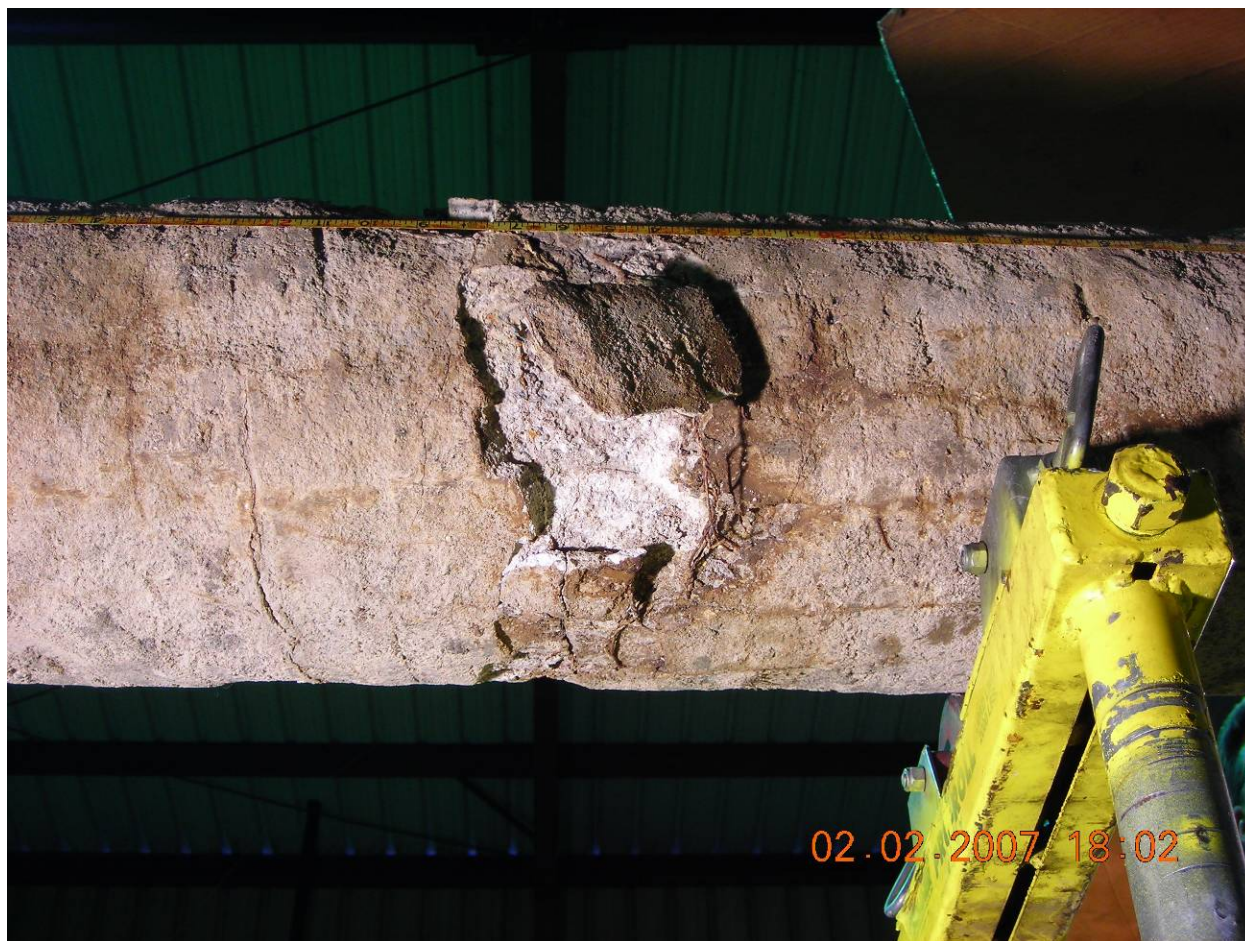
**Figure 22:** Cracked and spalled concrete coating located approximately 20.5 feet from the transverse fracture in the west portion of the sales gas line.

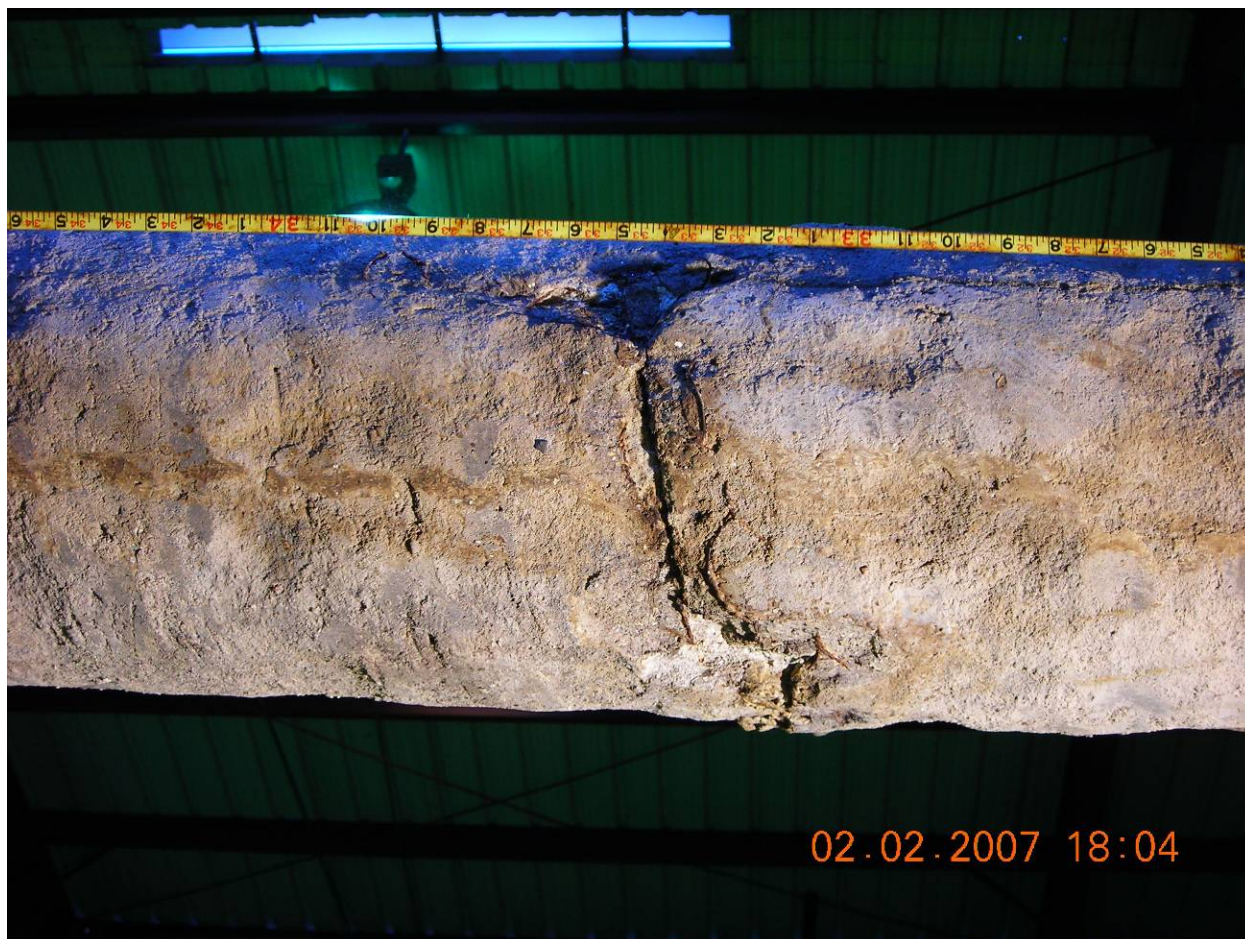
**Figure 23:** Cracked and spalled concrete coating located approximately 33.4 feet from the transverse fracture in the west portion of the sales gas line.

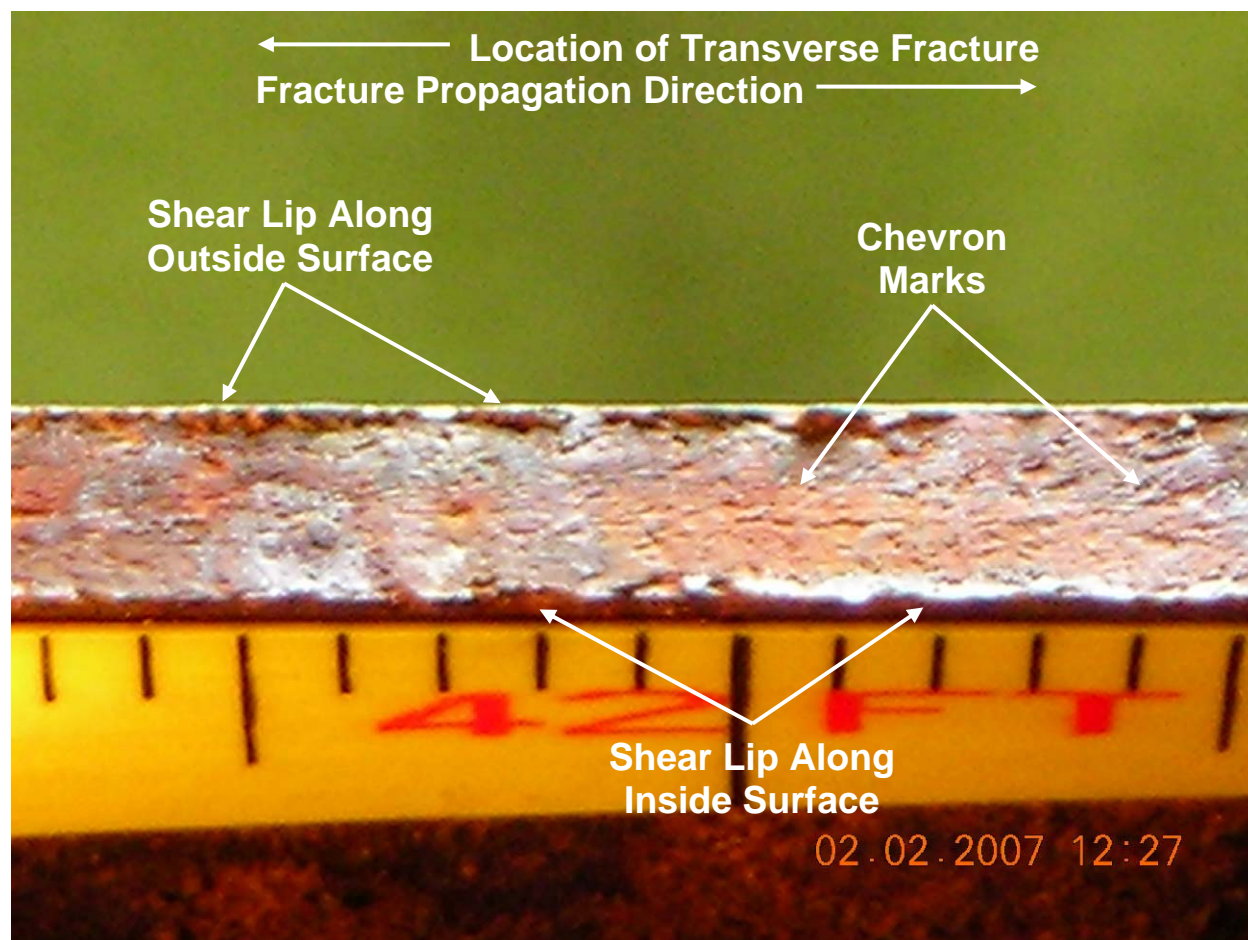
The fracture surfaces were examined visually and with the aid of magnifying glasses of up to 10X magnification. Most of the longitudinal fracture in the east portion was flat, oriented on a radial plane of the pipe, exhibited little plastic deformation, and displayed fine fractographic details. Shear lips were generally present along the inside and/or outside surfaces of the pipe. Figure 24 shows a close-up view of the longitudinal fracture surface approximately 42 feet east of the transverse fracture. This location is close to the circumferential field girth weld located approximately 43 feet east of the transverse fracture (Figure 7). Fine chevron marks indicate that, at this location, the fracture propagated to the east, away from the transverse-fractured end of the east portion. Shear lips are quite evident along both the inside and outside surfaces.

**Figure 24:** Close-up view of the longitudinal fracture surface approximately 42 feet east of the transverse fracture in the east portion of the sales gas line. Notice that most of the fracture surface is flat with little plastic deformation, fine fractographic details, and shear lips along the inside and outside surfaces of the pipe. Fine chevron marks indicate that the crack propagated to the east, away from the transverse fracture, at this location.

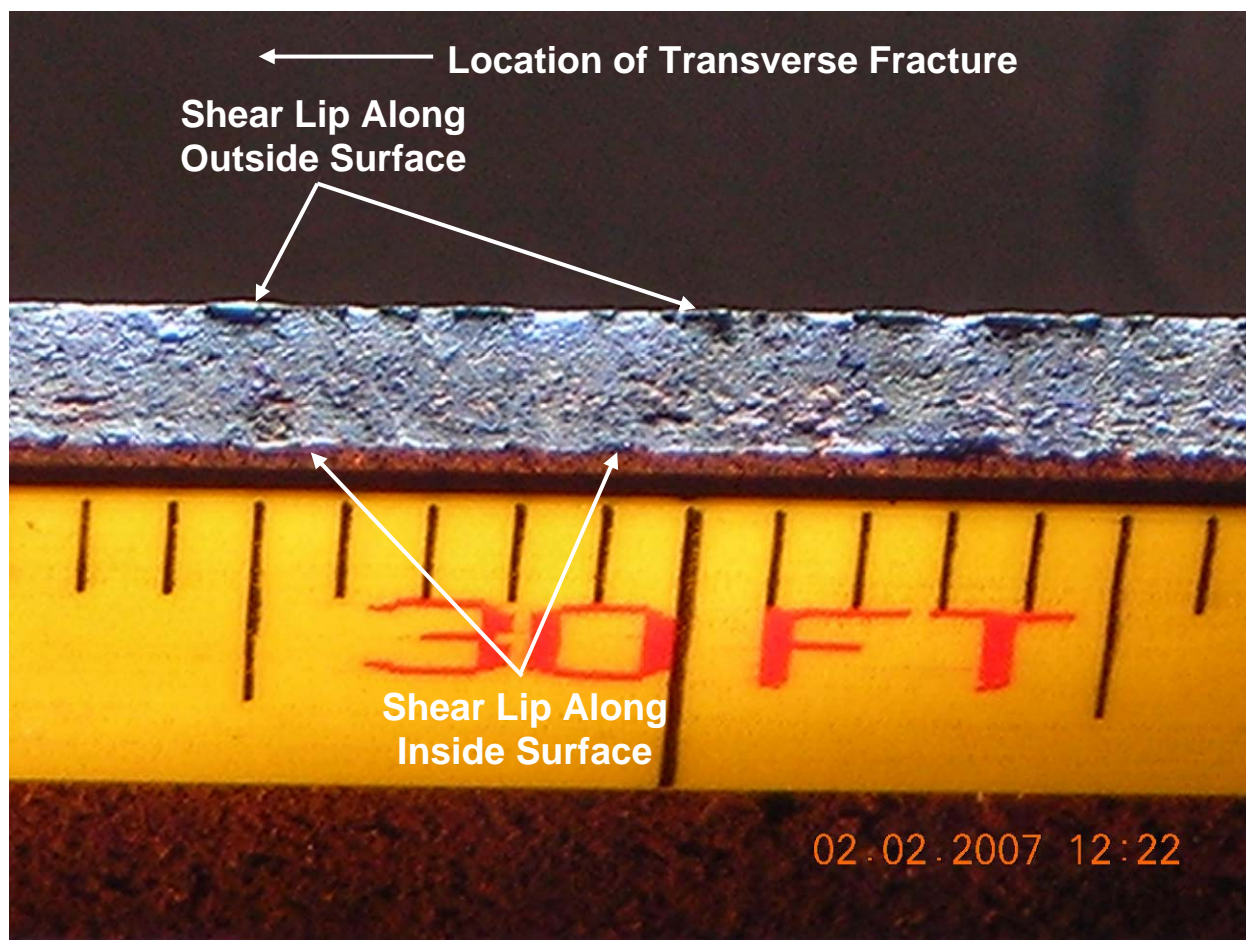
Figure 25 shows a close-up view of the longitudinal fracture surface approximately 30 feet to the east of the transverse fracture in the east portion of the sales gas line. At this location, the fracture features were similar to those observed 42 feet east of the transverse fracture; however, there were no clear chevron marks indicating the direction of fracture propagation.

**Figure 25:** Close-up view of the longitudinal fracture approximately 30 feet east of the transverse fracture in the east portion of the sales gas line. The fracture surface exhibits similar features as those shown in Figure 24; however, the fine fractographic details do not clearly indicate the fracture propagation direction.

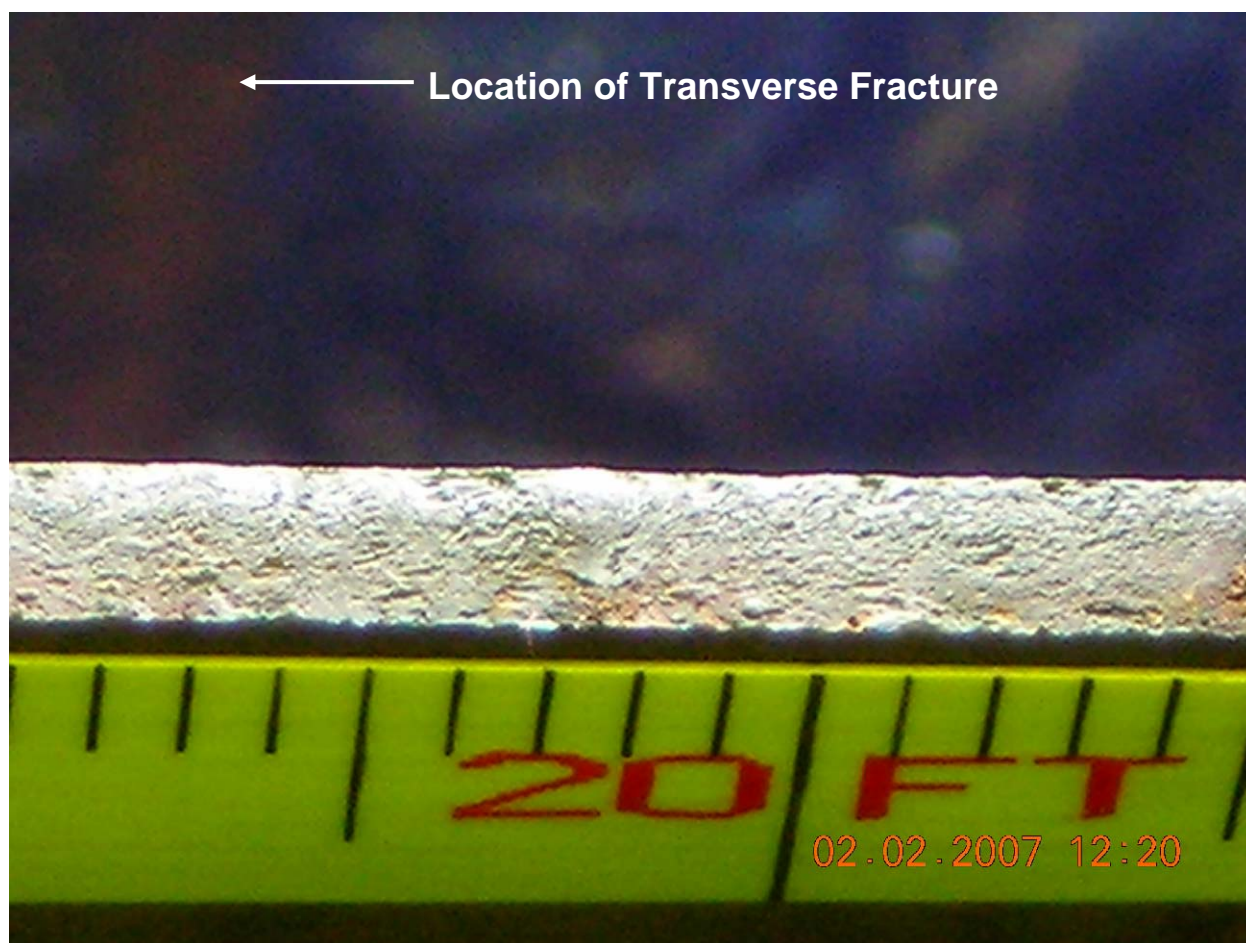
Figure 26 shows a similar view 20 feet east of the transverse fracture. The fracture features are similar to those of the 30-foot location, and there are not clear chevron marks indicating the direction of fracture propagation. The same is true approximately 10 feet east of the transverse fracture, as shown in Figure 27.

**Figure 26:** Close-up view of the longitudinal fracture approximately 20 feet east of the transverse fracture in the east portion of the sales gas line. The fracture features are similar to those of Figure 25; the fracture propagation direction is not clear.

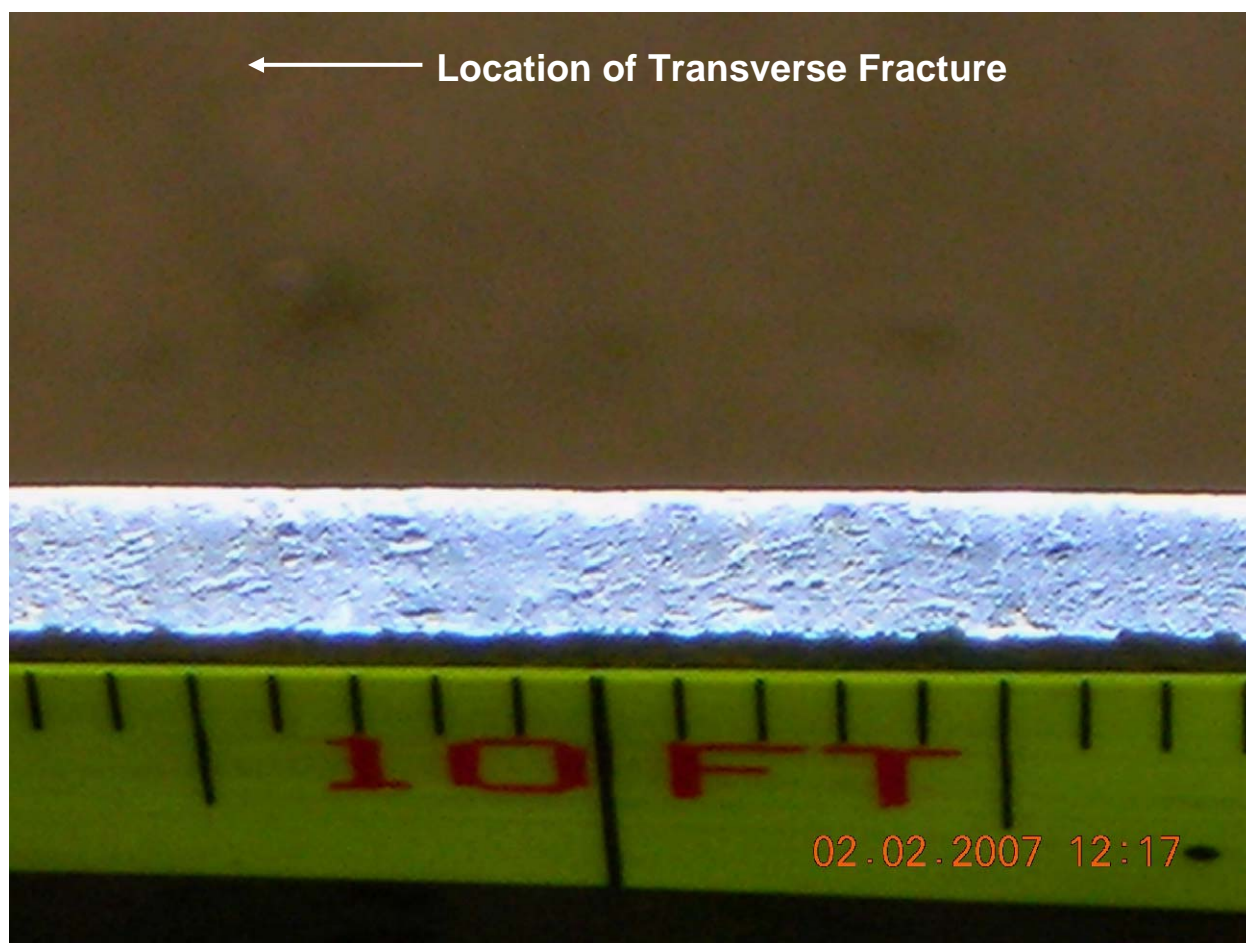
**Figure 27:** Close-up view of the longitudinal fracture approximately 10 feet east of the transverse fracture in the east portion of the sales gas line. The fracture features are similar to those of Figures 25 and 26; the fracture propagation direction is not clear.

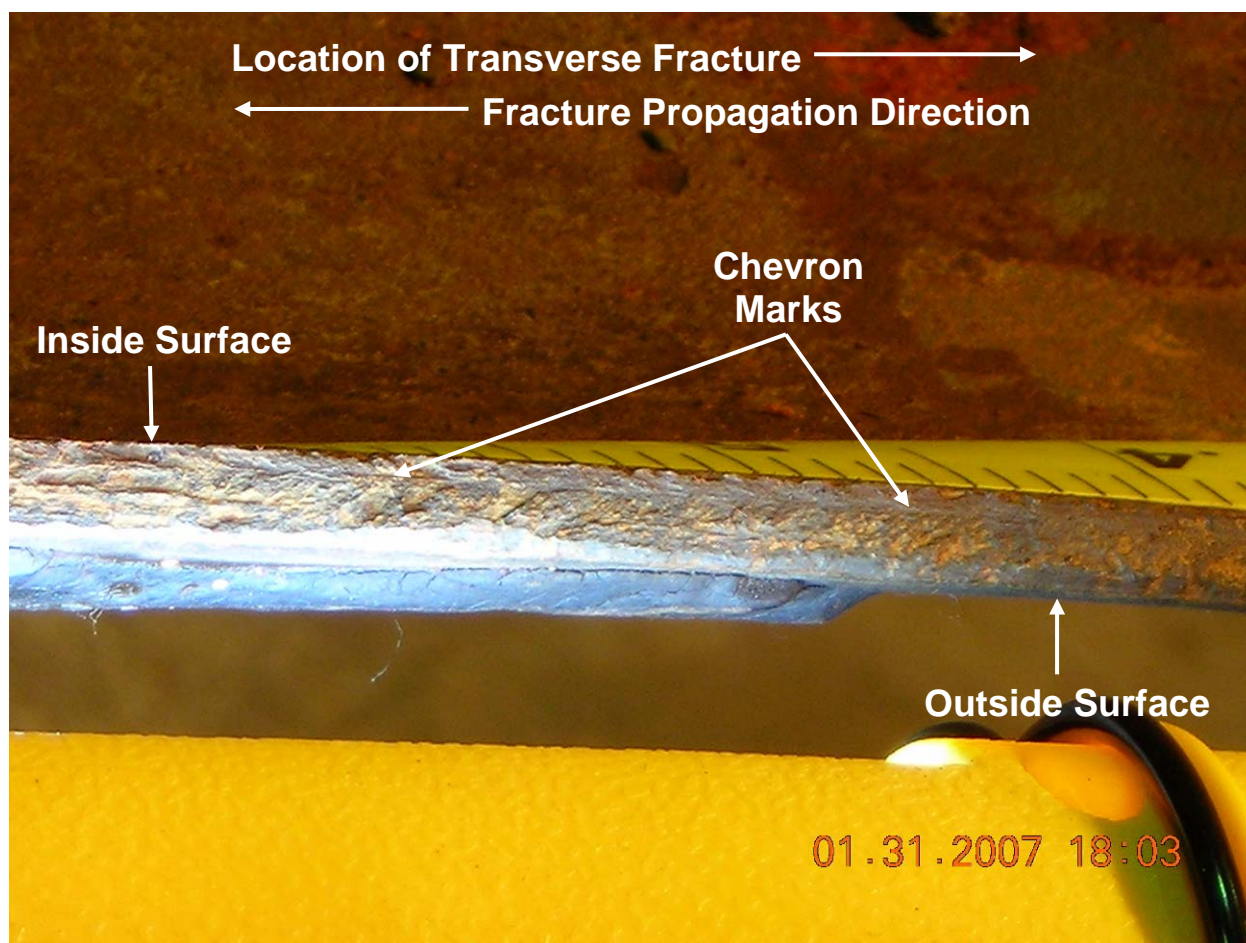
At a distance of approximately 1.5 feet east of the transverse fracture, chevron marks are distinct on the longitudinal fracture. The chevron marks indicate that the fracture propagated to the east at this location, as shown in Figure 28. Similar features were observed at a distance of approximately 1.3 feet east of the transverse fracture, as shown in Figure 29. Figure 29 also shows the west end of a bend in the longitudinal fracture surface resulting from the large dent shown in Figures 15 and 30.

**Figure 28:** Close-up view of the longitudinal fracture approximately 1.5 feet east of the transverse fracture in the east portion of the sales gas line. Notice the chevron marks indicating that the direction of fracture propagation was to the east, away from the transverse fracture.

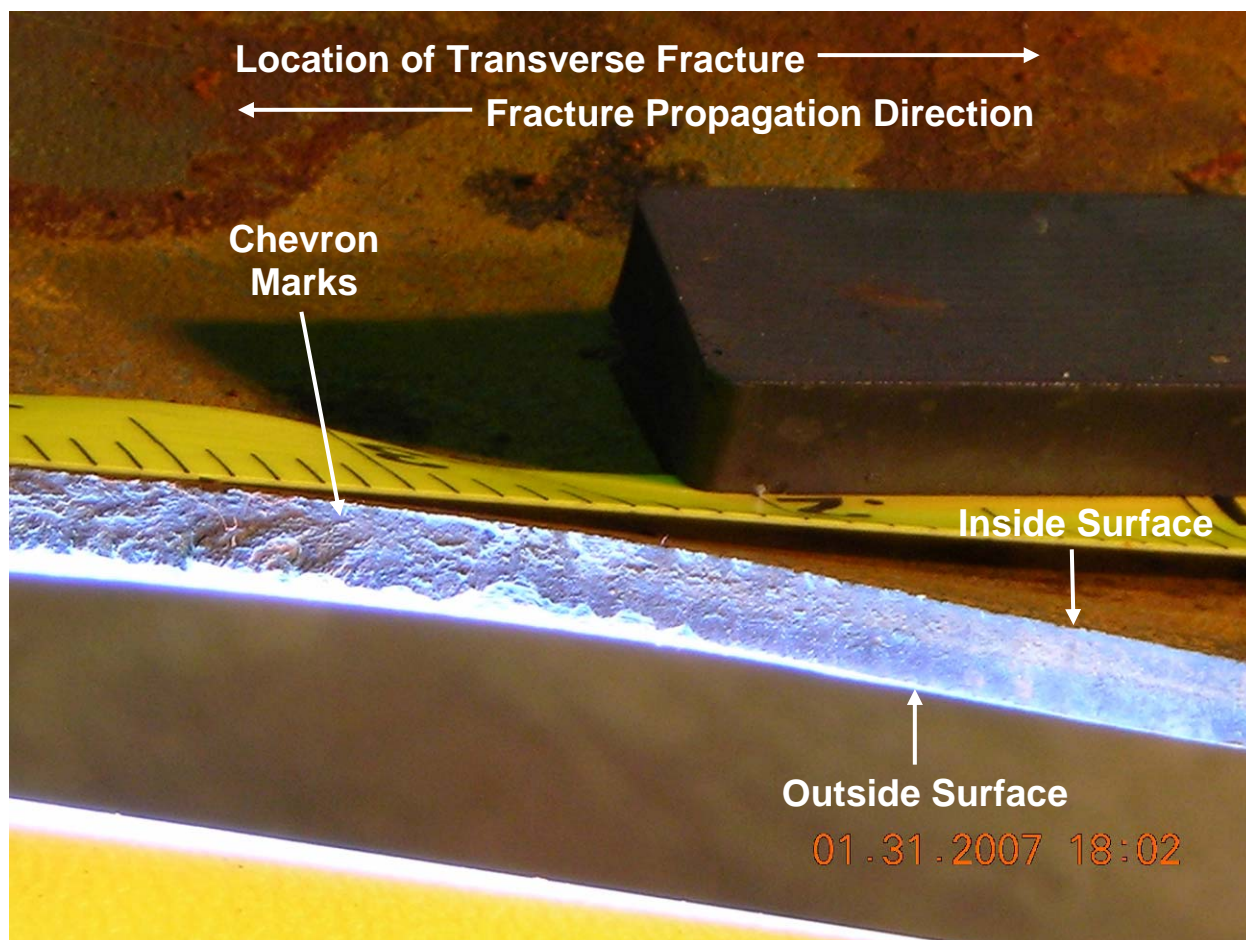
**Figure 29:** Close-up view of the longitudinal fracture approximately 1.3 feet east of the transverse fracture in the east portion of the sales gas line. Notice the chevron marks indicating that the direction of fracture propagation was to the east, away from the transverse fracture. Also notice the bend in the fracture resulting from the dent shown in Figures 15 and 30.

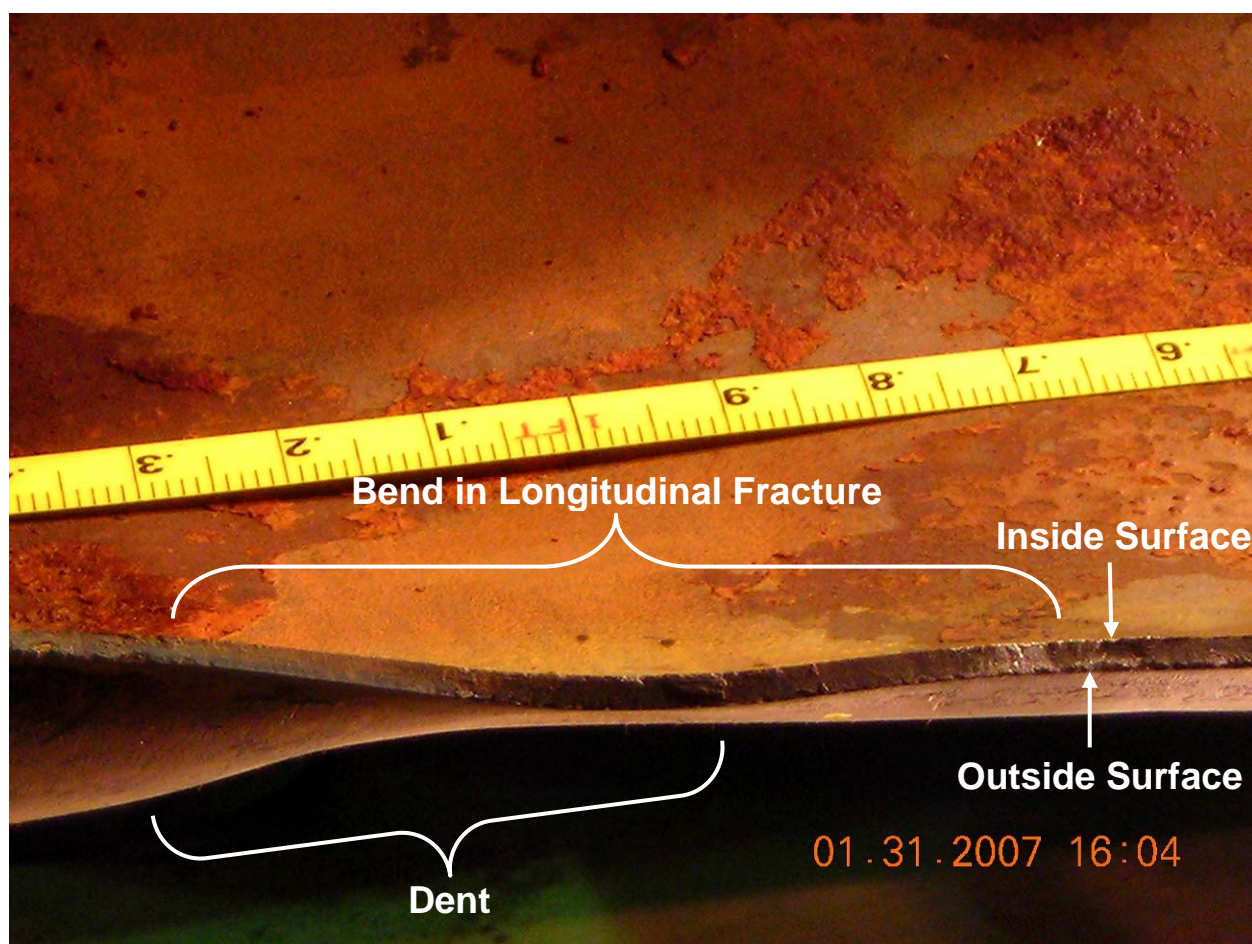
**Figure 30:** Bend in the longitudinal fracture located approximately 1 foot east of the transverse fracture in the east portion of the sales gas line. The bend was associated with the large dent shown in this photograph and Figure 15.

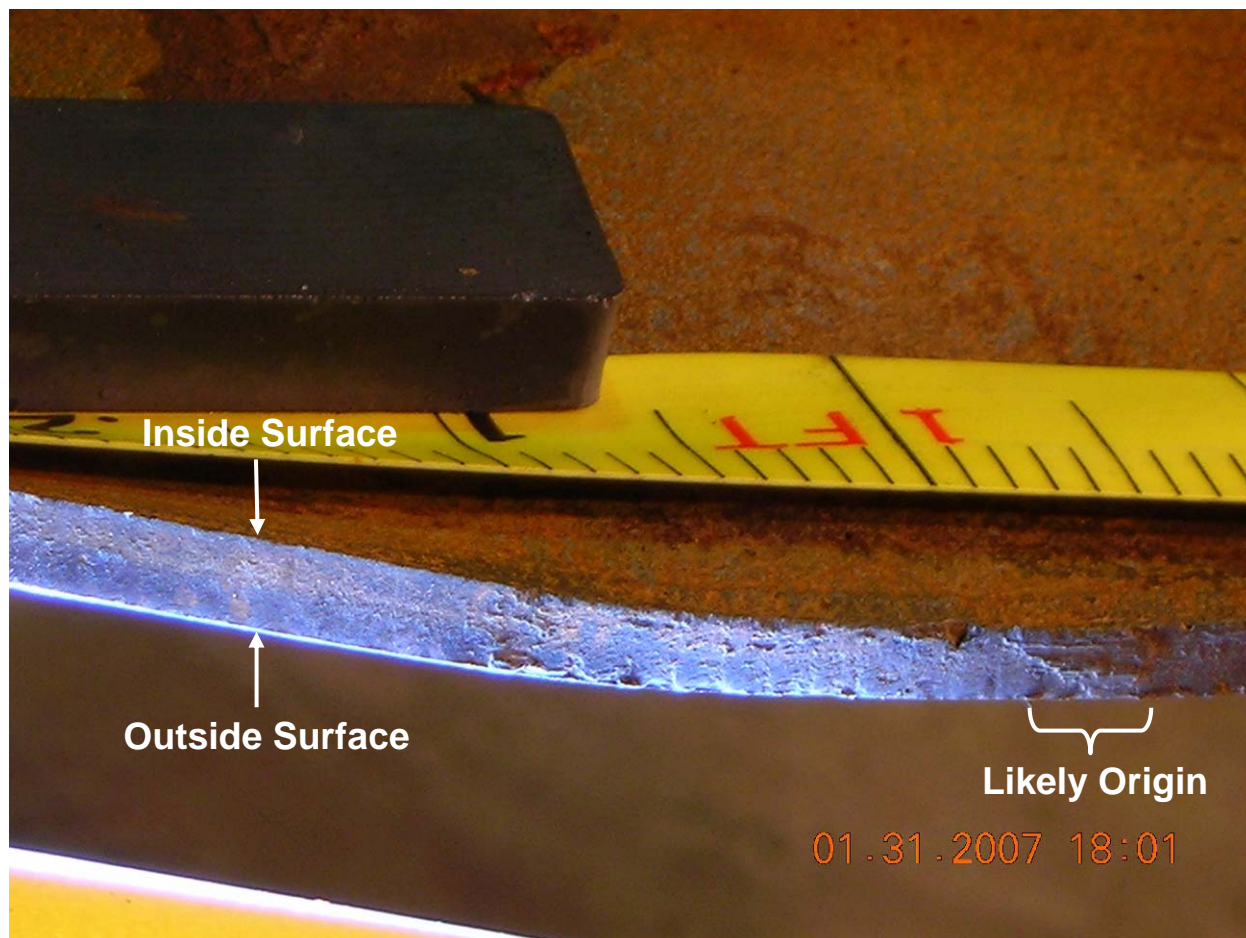
Figure 31 shows the longitudinal fracture at approximately 1 foot east of the transverse fracture, near the center of the bend. Clear chevron marks are not evident at this location, but a step change in the plane of the fracture indicates the most likely location of the fracture origin. The west side of the likely origin area is shown in Figure 32, which is centered at approximately 0.8 feet east of the transverse fracture.

**Figure 31:** Close-up view of the longitudinal fracture approximately 1 foot east of the transverse fracture in the east portion of the sales gas line. This location corresponds with the approximate center of the bend in the fracture associated with the dent shown in Figures 15 and 30. No clear chevron marks are evident; however, a step change in the plane of the fracture indicates the likely fracture origin.

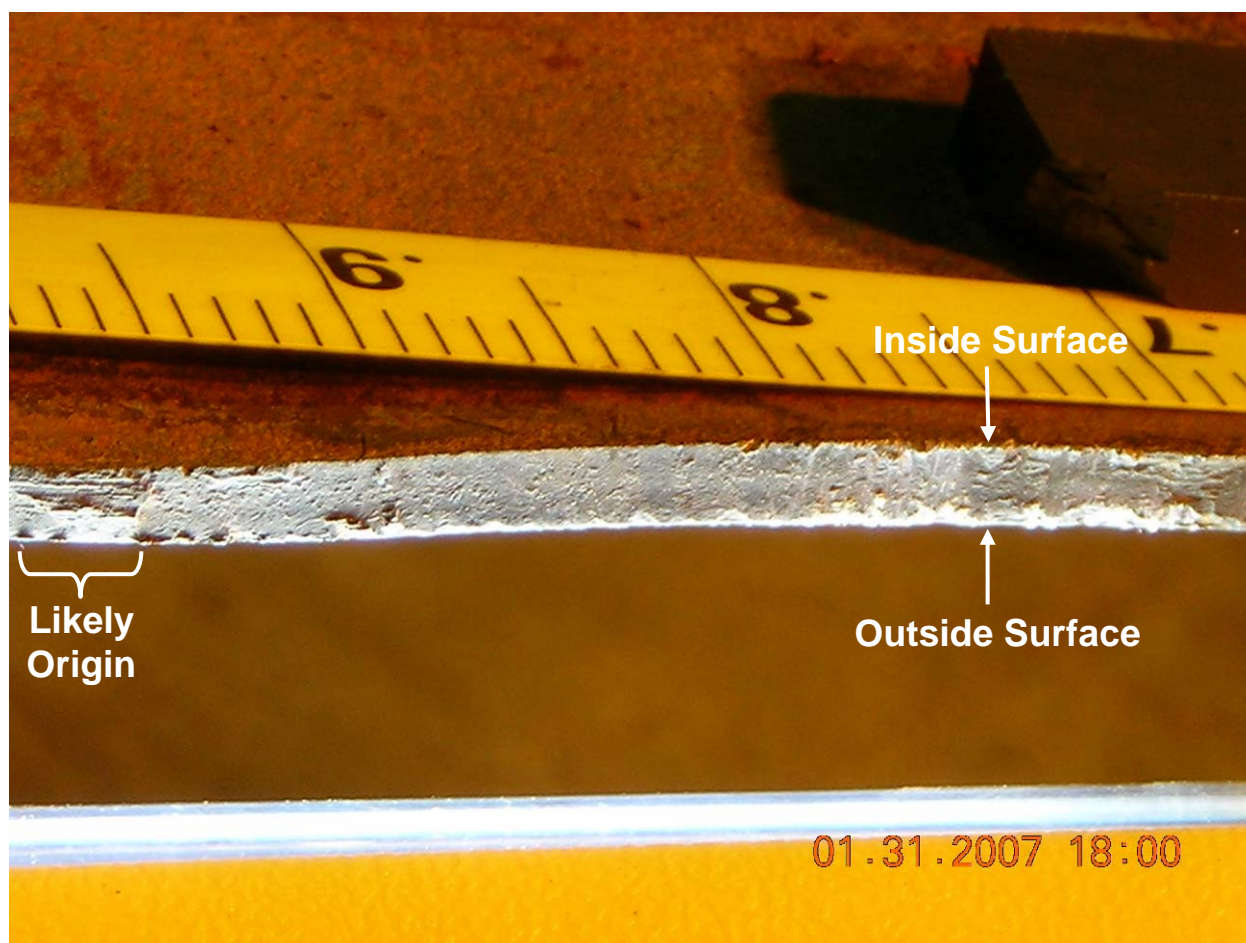
**Figure 32:** Close-up view of the longitudinal fracture approximately 0.8 feet east of the transverse fracture in the east portion of the sales gas line. No clear chevron marks are evident; however, a step change in the plane of the fracture indicates the likely fracture origin.

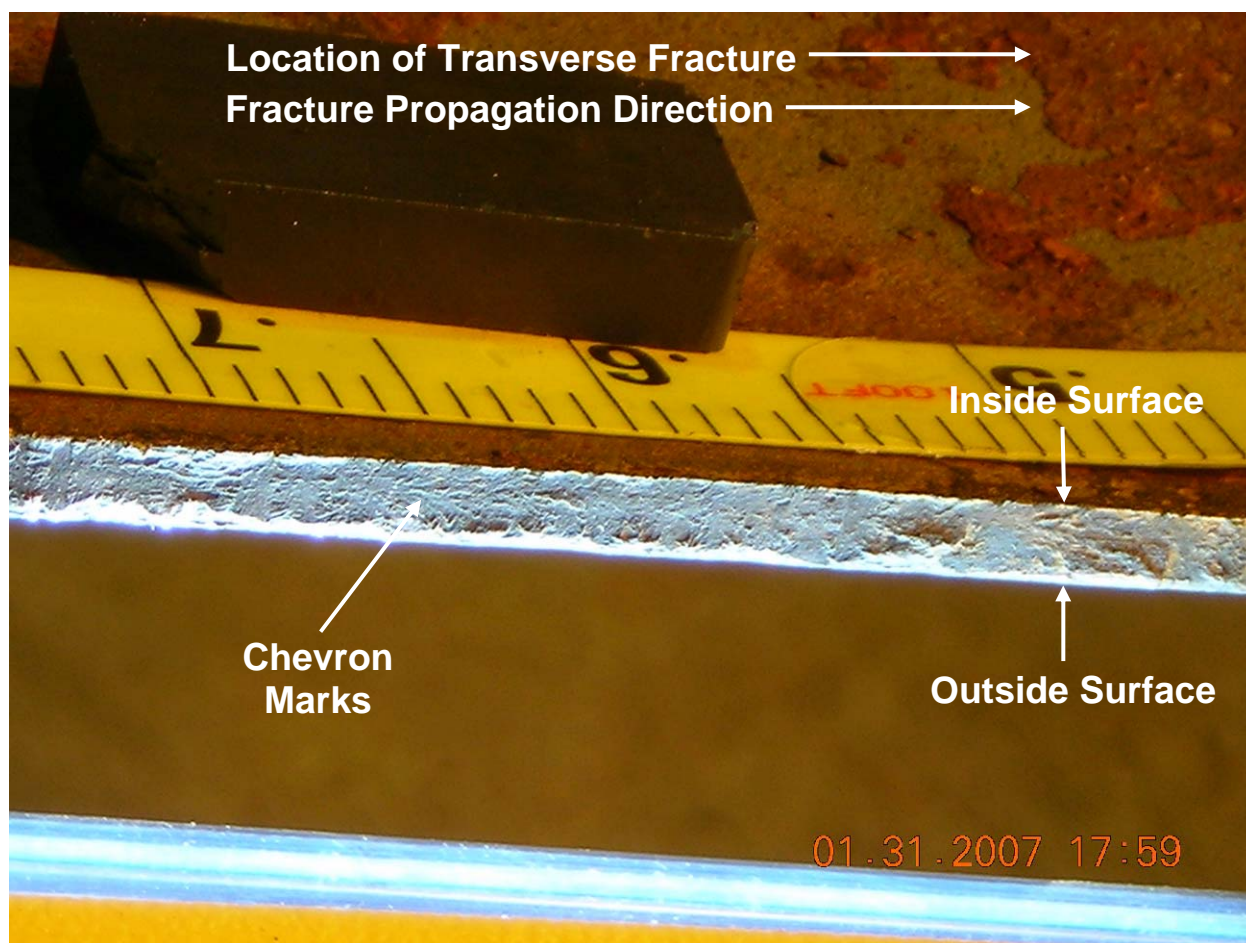
Further to the west at 0.6 feet from the transverse fracture, Figure 33 shows the resumption of chevron marks. These chevron marks indicate that the fracture propagated to the west, towards the transverse fracture. The reversal in the direction of fracture propagation is consistent with a fracture origin area located in the bend caused by the large dent shown in Figures 15 and 30.

**Figure 33:** Close-up view of the longitudinal fracture approximately 0.6 feet east of the transverse fracture in the east portion of the sales gas line. Chevron marks are again visible and indicate a change in the direction of fracture propagation to the west, towards the transverse fracture.

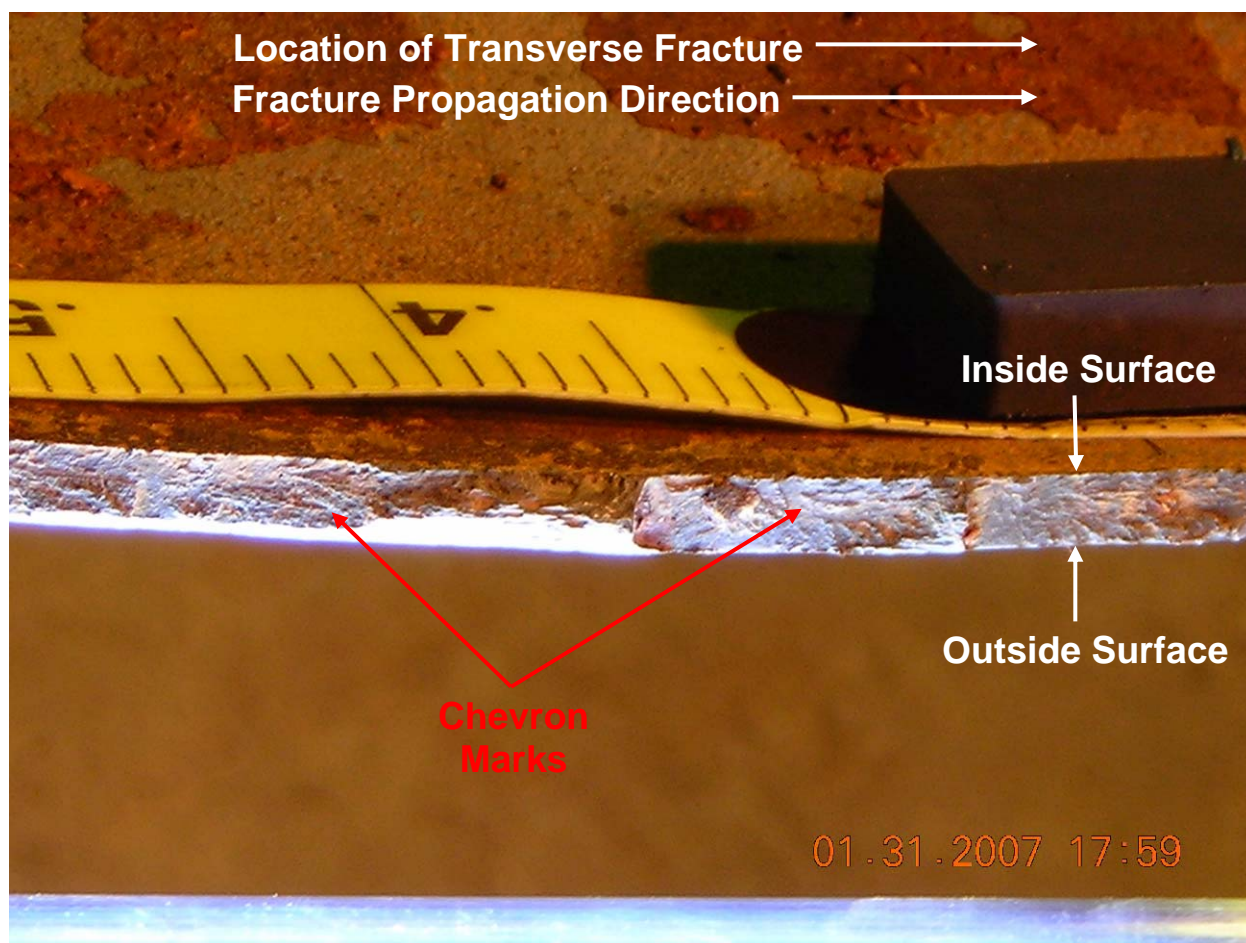
Figure 34 shows the longitudinal fracture at a distance of about 0.35 feet from the transverse fracture. More chevron marks are evident, and they indicate that the fracture continued propagating towards the west at this location.

**Figure 34:** Close-up view of the longitudinal fracture approximately 0.35 feet east of the transverse fracture in the east portion of the sales gas line. Chevron marks are visible and indicate that the fracture propagated to the west, towards the transverse fracture.

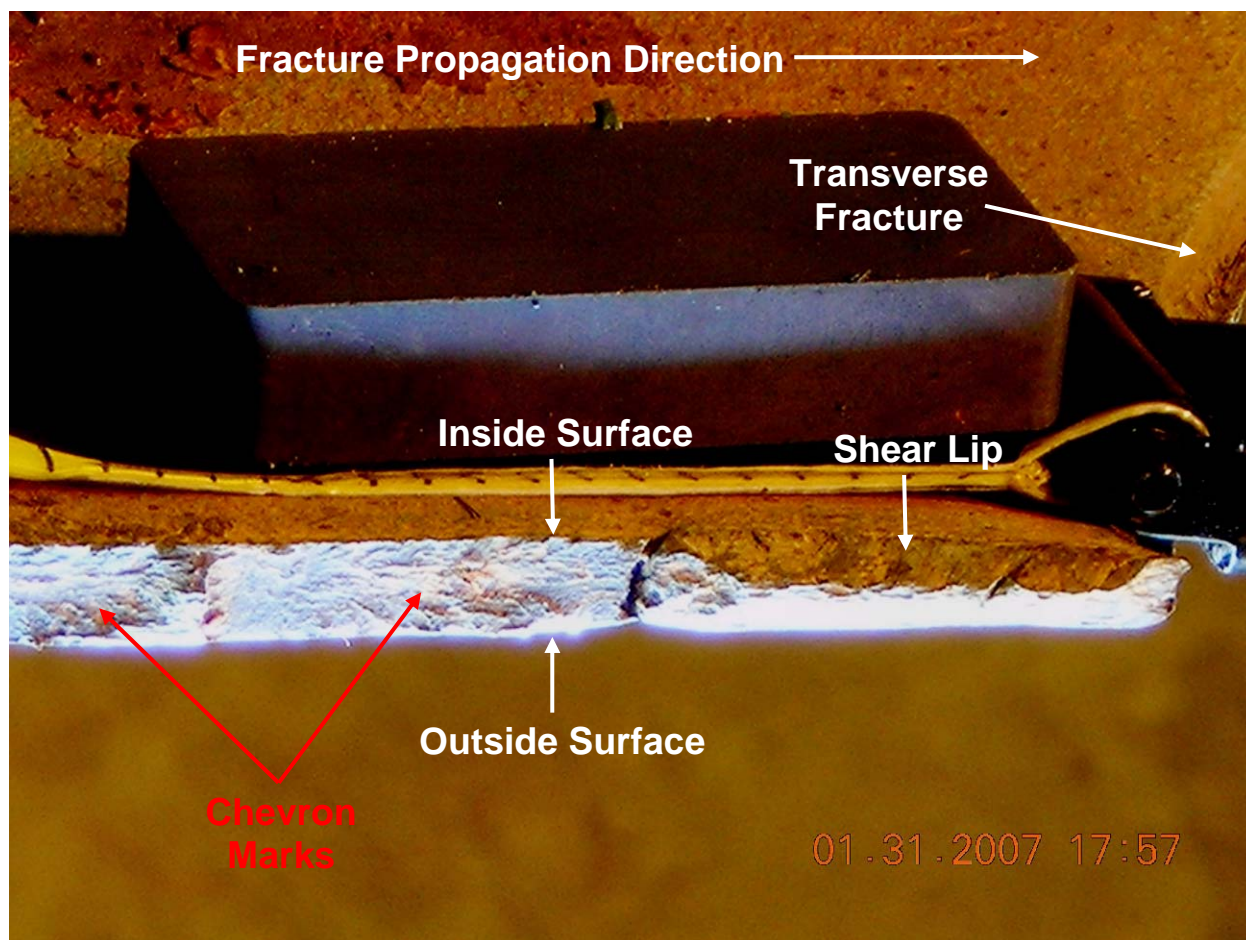
Figure 35 shows the west end of the longitudinal fracture in the east portion of the sales gas line. Chevron marks show that the fracture propagation direction continued toward the west at this location. A large shear lip developed where the longitudinal fracture met the transverse fracture.

**Figure 35:** Close-up view of the longitudinal fracture near its intersection with the transverse fracture in the east portion of the sales gas line. Chevron marks indicate that the fracture propagated to the west, towards the transverse fracture and away from the likely origin area at the large dent. A large shear lip is evident at the end of the longitudinal fracture.

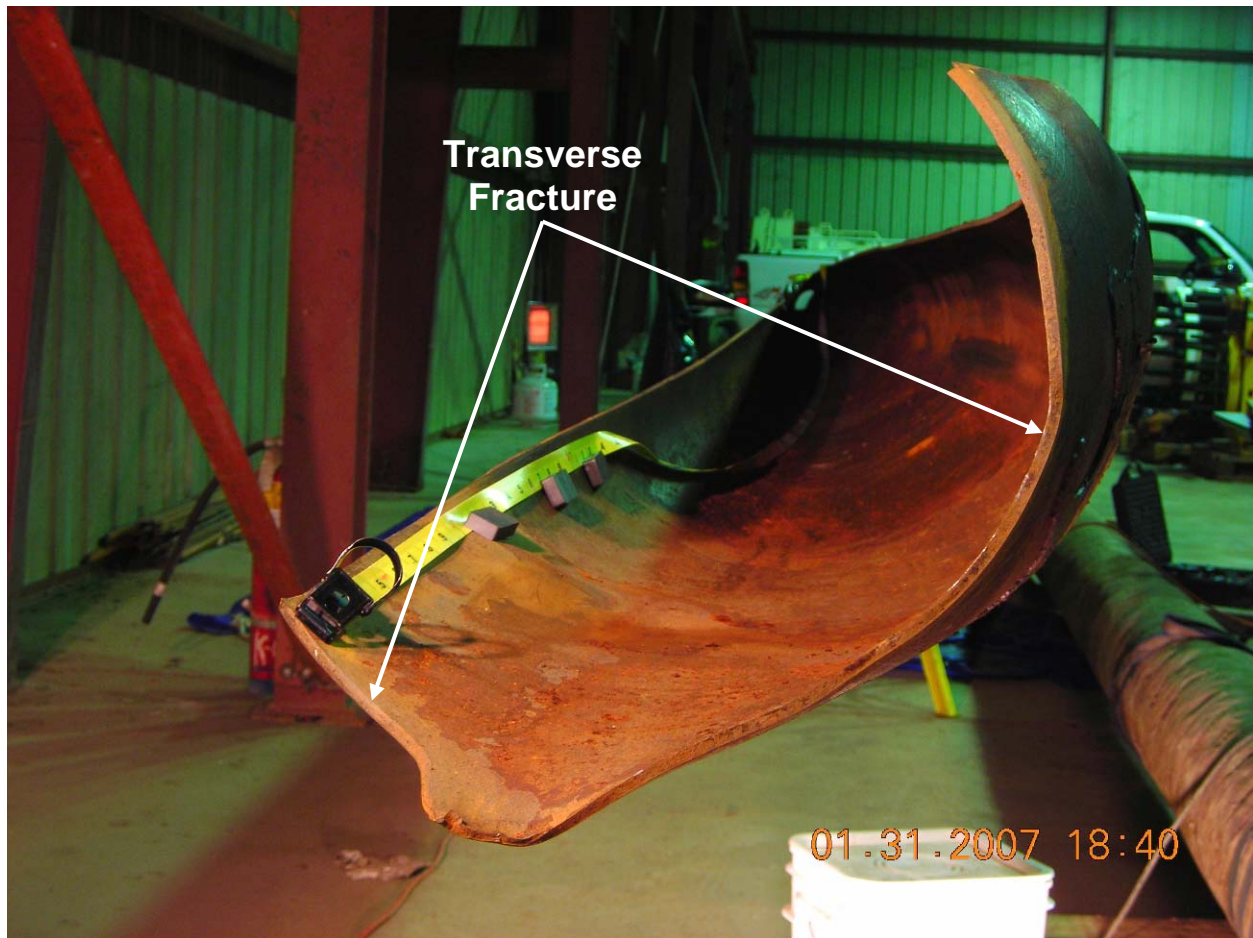
Figure 36 shows the transverse fracture on the west end of the east portion of the sales gas line. The fracture features, shown close-up in Figure 37, are consistent with ductile tearing. The direction of fracture propagation is not evident. The edge of the transverse fracture surface along

**Figure 36:** The transverse fracture on the west end of the east portion of the sales gas line.

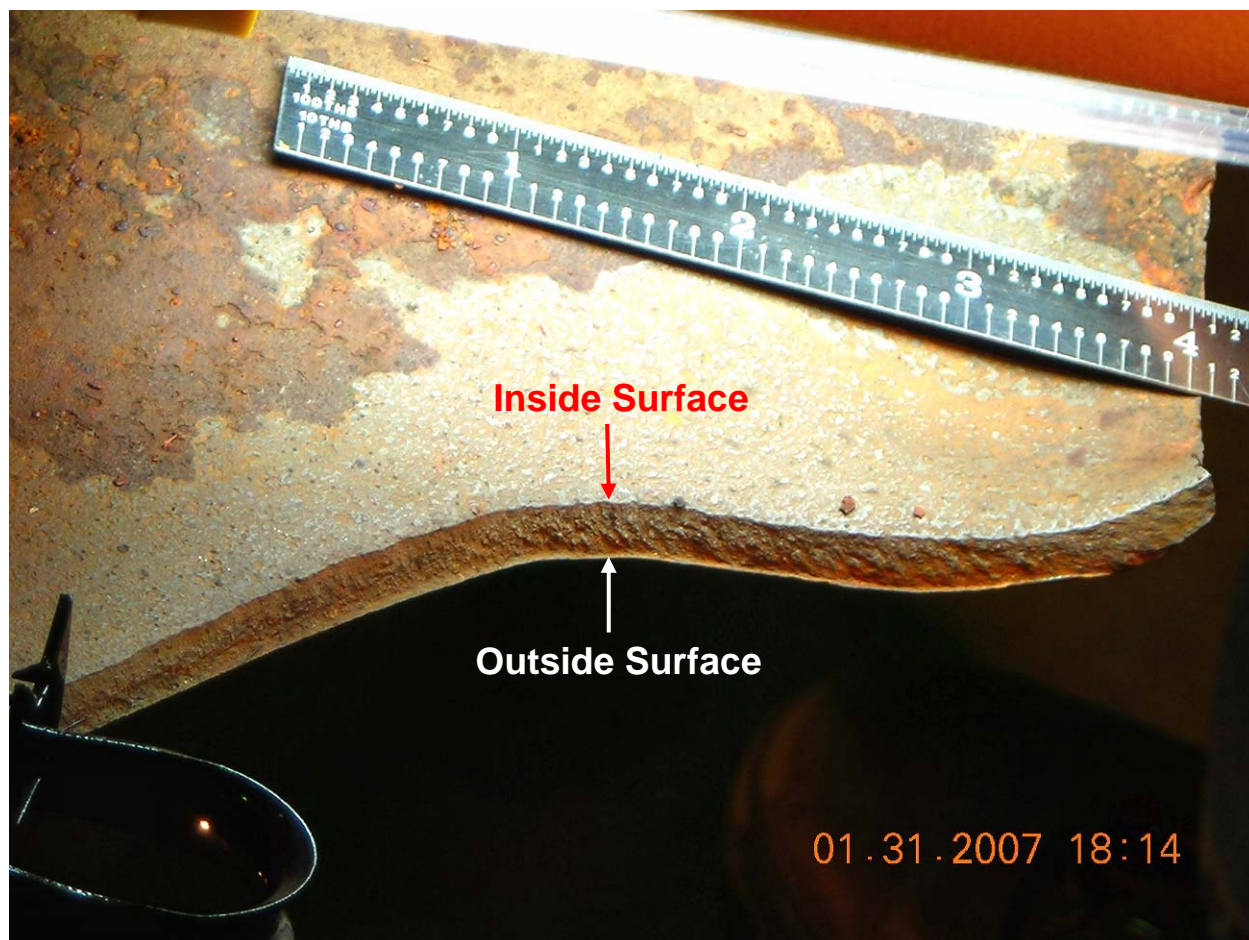
**Figure 37:** Close-up view of the transverse fracture surface adjacent to the longitudinal fracture in the east portion of the sales gas line.

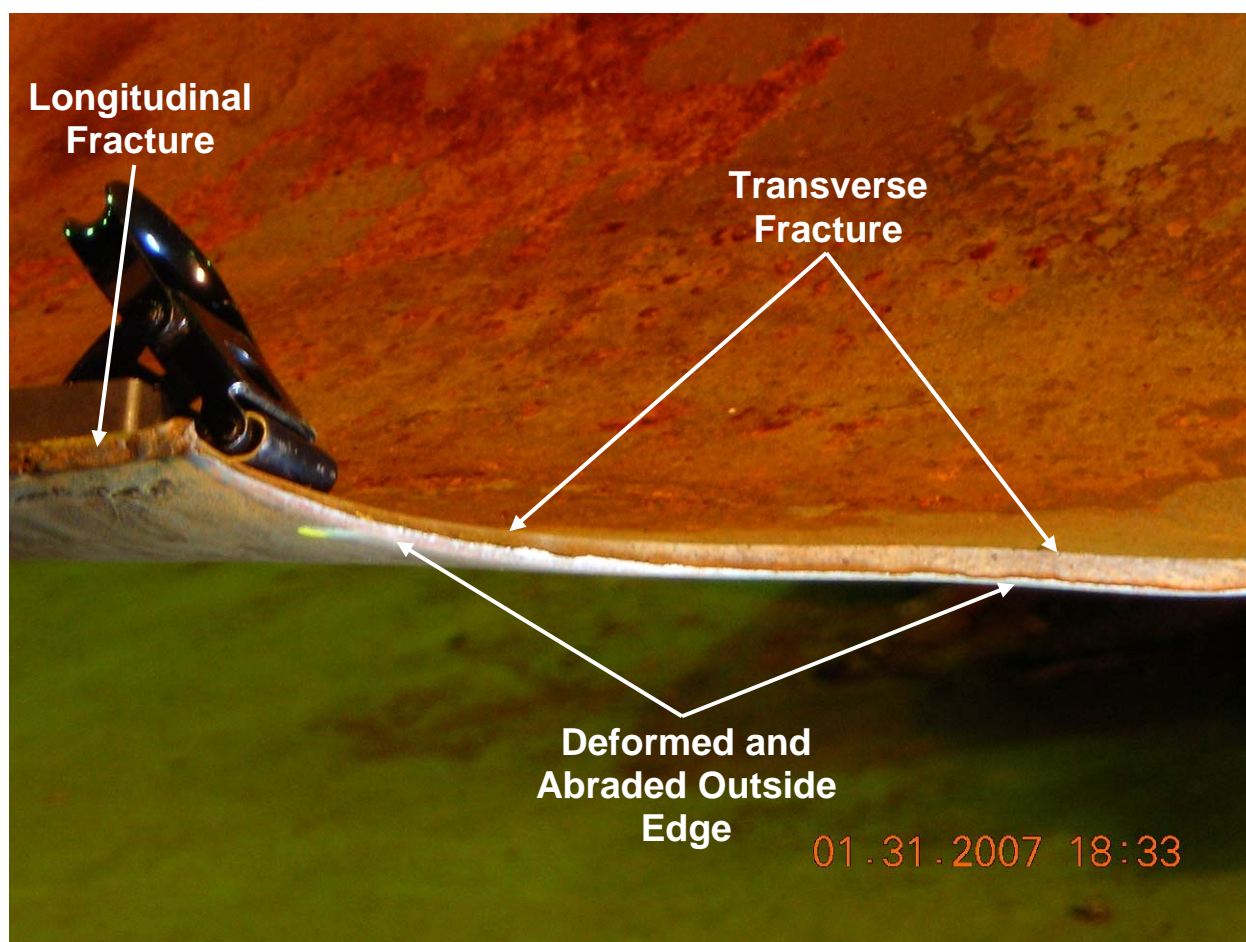
the outside surface of the pipe was deformed and abraded on the left end of the transverse fracture shown in Figure 36. The damage, shown in Figure 38, was apparently caused by impact with a foreign object following the fracture.

**Figure 38:** The left end of the transverse fracture shown in Figure 36. Notice that the outside edge of the fracture has been deformed and abraded, apparently by impact with a foreign object, following the fracture.
